**EXHIBIT****Gu (ZHP) 232****Final GMP inspection report**

Joint inspection between EMA (AIFA/AEMPS) and EDQM (in the context of the Inspection Programme of manufacturers within the Certification Procedure)

**N-Nitroso-
dimethylamine
determination in
Valsartan APIs
Project 18/091**

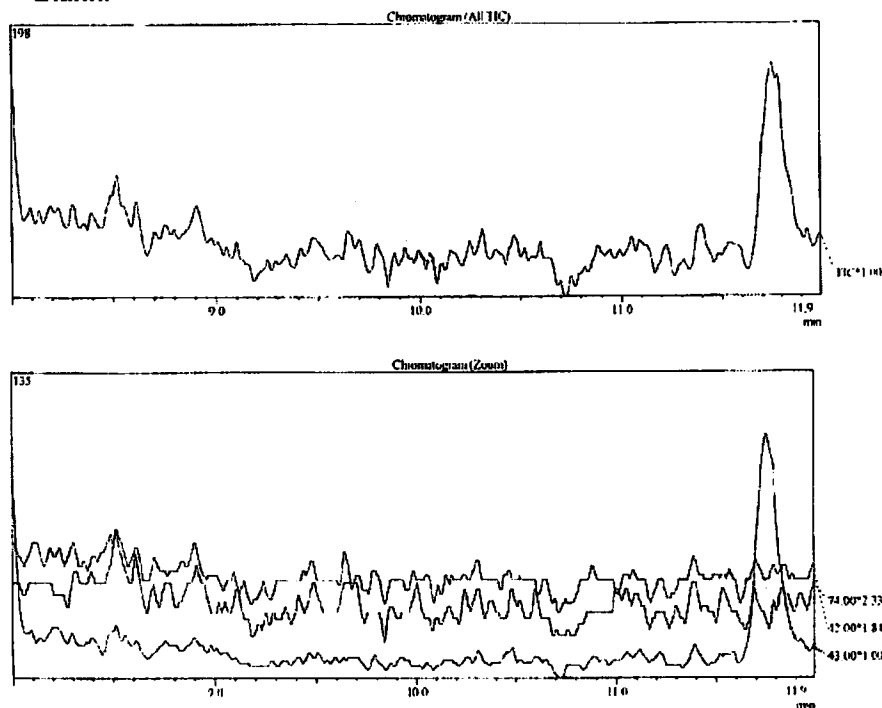
Blank:

4. Chromatographic Examples:

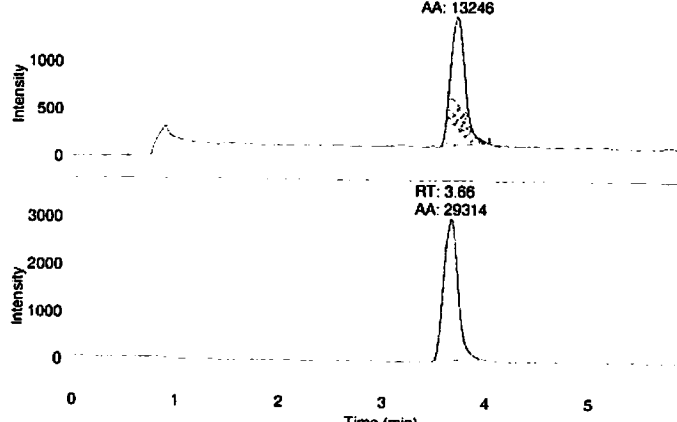
<p>NL: 3.24E2 TIC F: ITMS + c APCI corona SIM ms [74.50-75.50] MS 180826_Valsartan0 01</p> <p>NL: 1.91E2 TIC F: ITMS + c APCI corona SIM ms [80.50-81.50] MS 180826_Valsartan0 01</p>	<p>Blank</p> <p>MS of NDMA MS of NDMA-d6</p>
<p>D:\Data LCMS2\180826_Valsartan011</p> <p>NDMA - NDMA-d6 0.05ug/mL STD</p> <p>RT: 0.00 - 5.99 SM: 7B</p>
